# Manhole Inspection Summary

Manhole # S41A\_\_043MH

Insp Date: **11/17/08 11:58 AM**

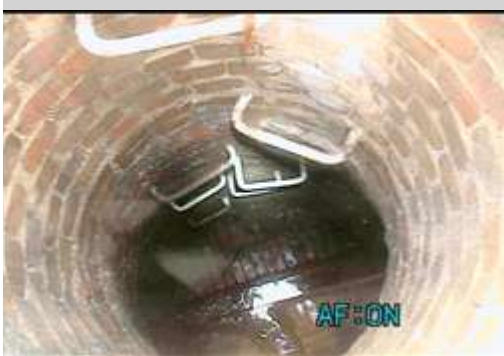
Defect 1

Count: **8** Missing: **0** ☒ **Corroded**

cor. steps

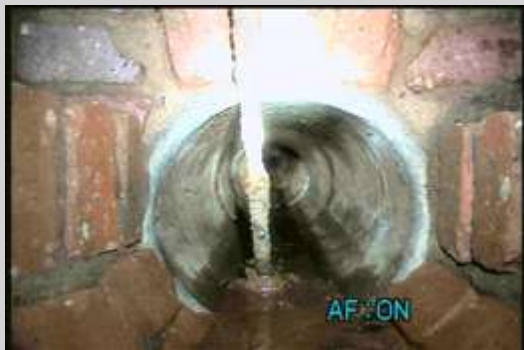
12 O'Clock Outflow

10 in. Circular Gravity Sewer  
Pipe Out @ 12 O'Clock

Pipe Material: **Clay** ☐ Pipe Lined

Invert Depth: **12.00** (ft.) Flow Characteristics: **None**

Deposits: ☒ None ☐ Mud ☐ Sludge ☐ **Debris** ☐ Grease

Infiltration: **None**

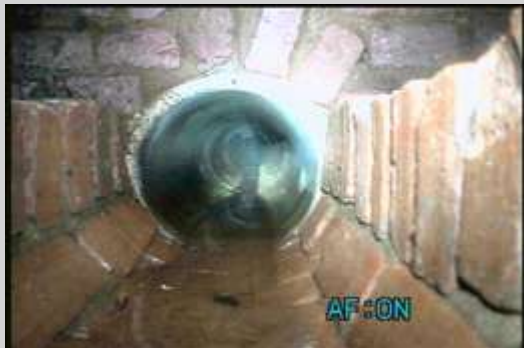
6 O'Clock Inflow

8 in. Circular Gravity Sewer  
Pipe In @ 6 O'Clock

Pipe Material: **Clay** ☐ Pipe Lined

Invert Depth: **11.96** (ft.) Flow Characteristics: **None**

Deposits: ☒ None ☐ Mud ☐ Sludge ☐ **Debris** ☐ Grease

Infiltration: **None**

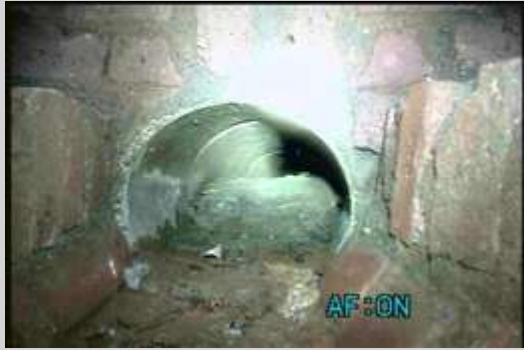
9 O'Clock Inflow

8 in. Circular Gravity Sewer  
Pipe In @ 9 O'Clock

Pipe Material: **Clay** ☐ Pipe Lined

Deposits: ☐ None ☐ Mud ☐ Sludge ☒ **Debris** ☐ Grease

Silt Depth: 0 (in.) Deposits Extent: **Medium**

Connects To: **House connection / Service line**
